Fire behaviour of reinforced concrete slabs under combined biaxial in-plane and out-of-plane loads

Fire behaviour of reinforced concrete slabs under combined bi-axial in-plane and out-of-plane loads

Abstract: To better understand the fire behaviour of in-plane restrained reinforced concrete slabs, this paper presents six fire tests on two-way spanning concrete slabs under compressive bi-axial in-plane and flexural out-of-plane loads. The data presented include furnace temperatures, temperature distributions, vertical and horizontal deflections, restraint forces, crack patterns, and characterisation of spalling of the six slabs during both heating and cooling phases. Comparison of the results indicates that bi-axial in-plane loads may have a negative effect on the vertical and horizontal deflection trends of the restrained slabs in fire. In addition, snap through behaviour and subsequent severe reversals of deflection trends were observed for the first time in concrete slabs with sustained bi-axial in-plane restraint during heating and cooling stages. Fire behaviour of the restrained slabs were considerably different from those of the simply supported slabs, and thus the effect of

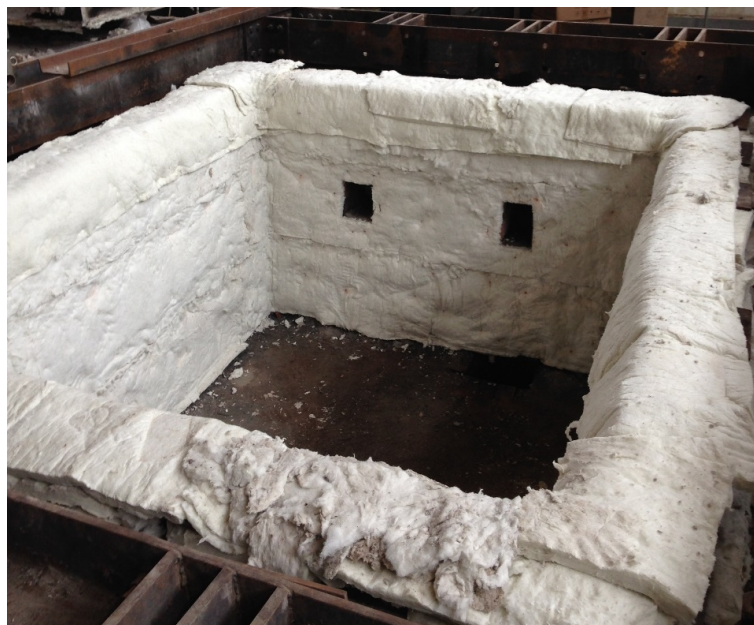
Fig. 1. Self-design furnace (all dimensions in mm).

(a) Plan view of the furnace

(b) External view of the self-designed furnace

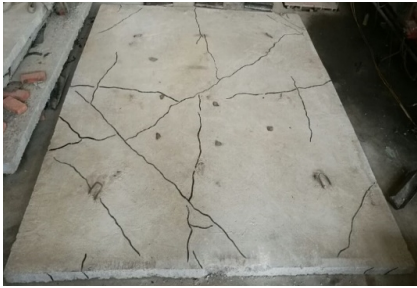
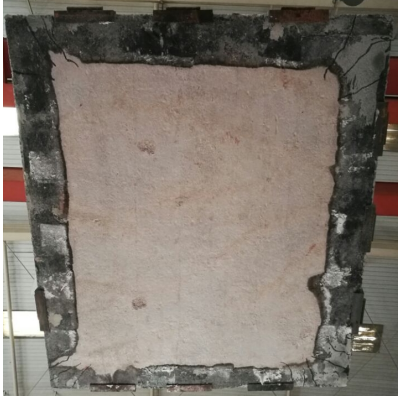
<p>(a) cracking pattern on the top surface</p>	<p>(b) cracks' development during the test</p>

<p>(c) spalling on the bottom surface</p>	<p>(d) cracking patter on the bottom surface</p>
<p>Fig. 19. Failure models of Slab R3: (a) cracking pattern on the top surface, (b) cracks' development, (c) spalling and (d) cracking patter on the bottom surface</p>

On one hand, for the rectangular Slabs R3 and R4, their cracking patterns are similar to each other, but different from that of the square Slabs S5 and S6. For instance, for Slabs R3 and R4, one or two cracks across the long and short spans appeared on the top surface with many longer cracks. In contrast, for Slabs S5 and S6, apart from the corners' cracks, one whole span crack parallel to the larger in-plane forces can be seen on the top surface. Meanwhile, three holes appeared in Slab S5 due to the serious spalling. It is found that the crack patterns of Slabs S5 and S6 were similar to those of Slabs S2 to S4 under uniaxial restraint, but different from that of the simply supported Slab S1 [18].

On the other hand, little concrete spalling, fewer cracks and no whole length crack were observed on the bottom surfaces of Slabs R3 and R4, regardless of the higher biaxial in-plane forces. In contrast, as shown in Figs. 21(c) and 22(c), very serious spalling occurred on the bottom surface of Slabs S5 and S6 with the fewer corners' cracks, particularly Slab S5. For instance, the spalling areas of Slabs S5 and S6 were 5.3m² and 0.7m², respectively, with the maximum depth of 100mm (holes) and 45mm.
